Manhole Inspection Summary

Manhole # S23K__049MH

Location Address: **302-304 Norris St**

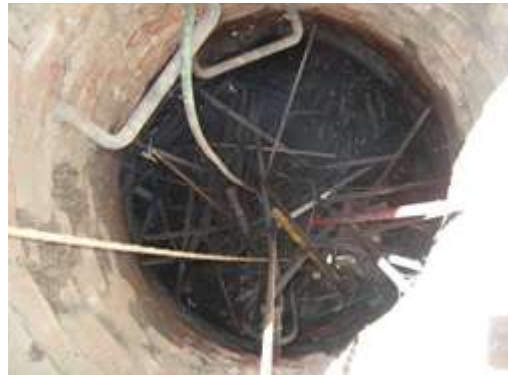
Top View

debris in bench, channel

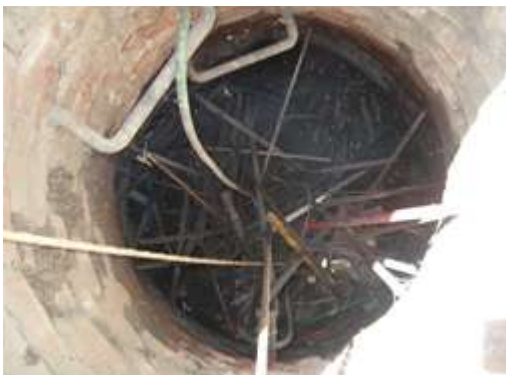
Defect 3

channel debris

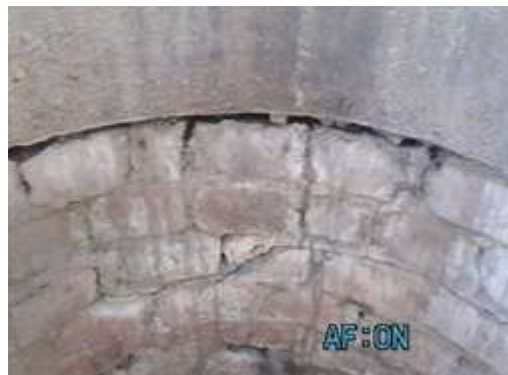
Defect 2

Condition: ☐ Sound ☒ **Cracked** ☐ Root Intrusion ☐ Loose Brick ☒ **Deteriorated**

Infiltration: ☐ None ☒ **Joint** ☐ Cracks ☒ **Mortar** ☐ Roots ☐ Wall

chimney has cracked bricks & signs of infiltration from joint & mortar

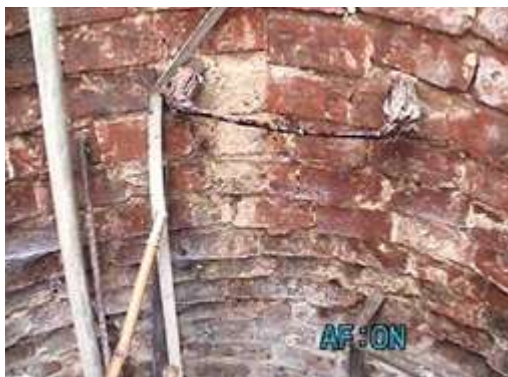
Defect 1

Count: **4** Missing: **0** ☒ **Corroded**

corroded rungs

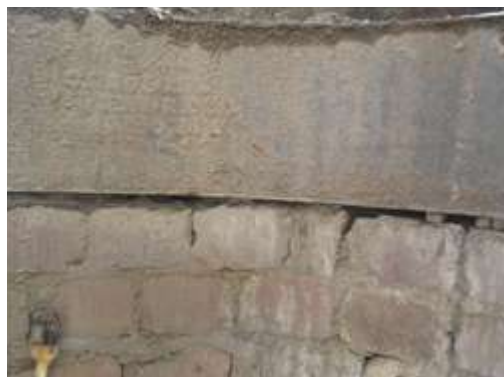
Defect 5

deteriated chimney frame connect

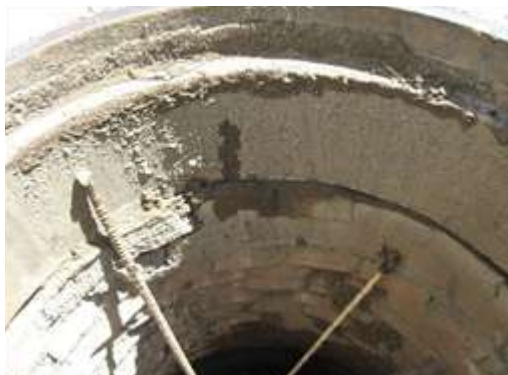
Defect 4

Condition: ☐ Sound ☐ Cracked ☒ **Leaks**

chimney deteriorated & infiltration, frame leaks

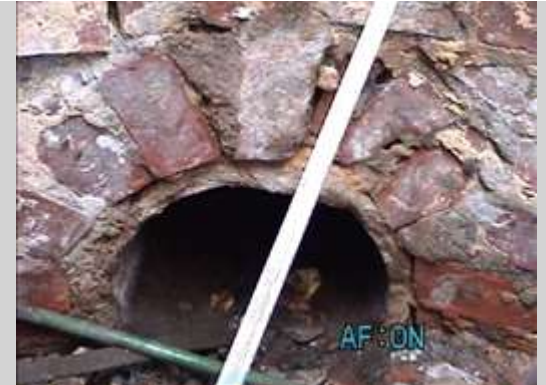
12 O'Clock Outflow

Deposits: ☐ None ☒ **Mud** ☐ Sludge ☒ **Debris** ☐ Grease

Silt Depth: **4** (in.) Deposits Extent: **Heavy**
